WIRING DIAGRAMS

1988 Volvo 740

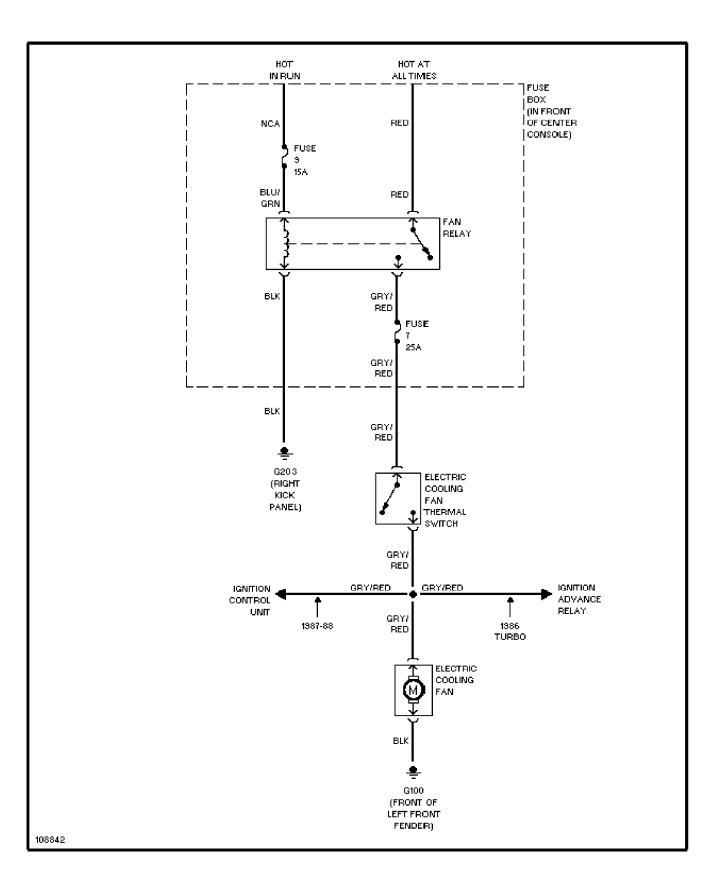
SYSTEM WIRING DIAGRAMS Cooling Fan Circuit

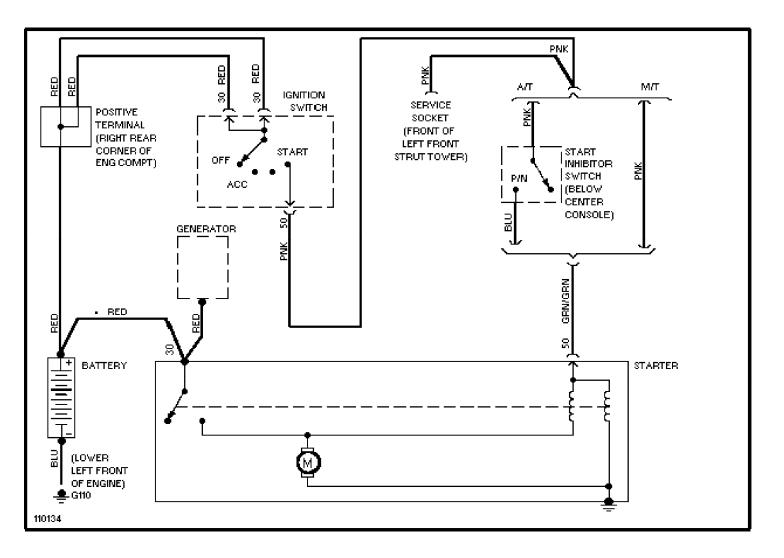
SYSTEM WIRING DIAGRAMS Starting Circuit

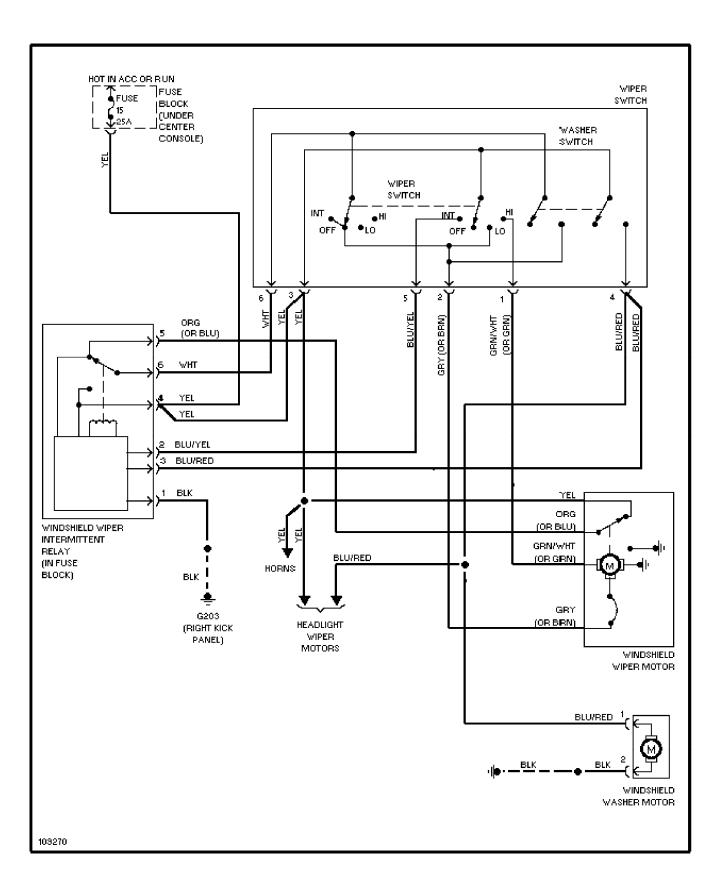
SYSTEM WIRING DIAGRAMS Front Wiper/Washer Circuit

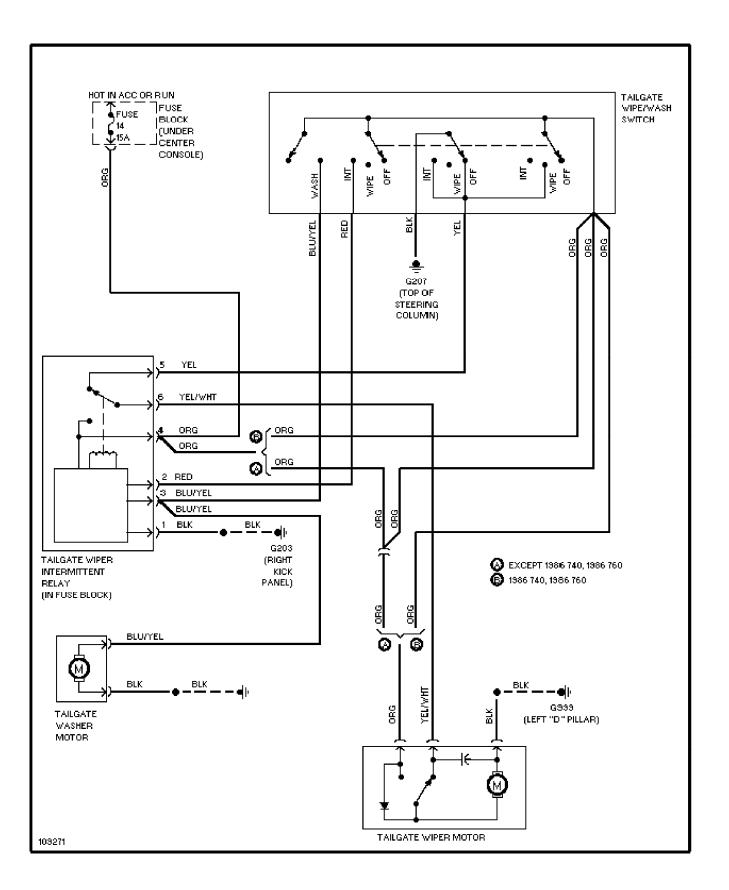
SYSTEM WIRING DIAGRAMS Rear Wiper/Washer Circuit

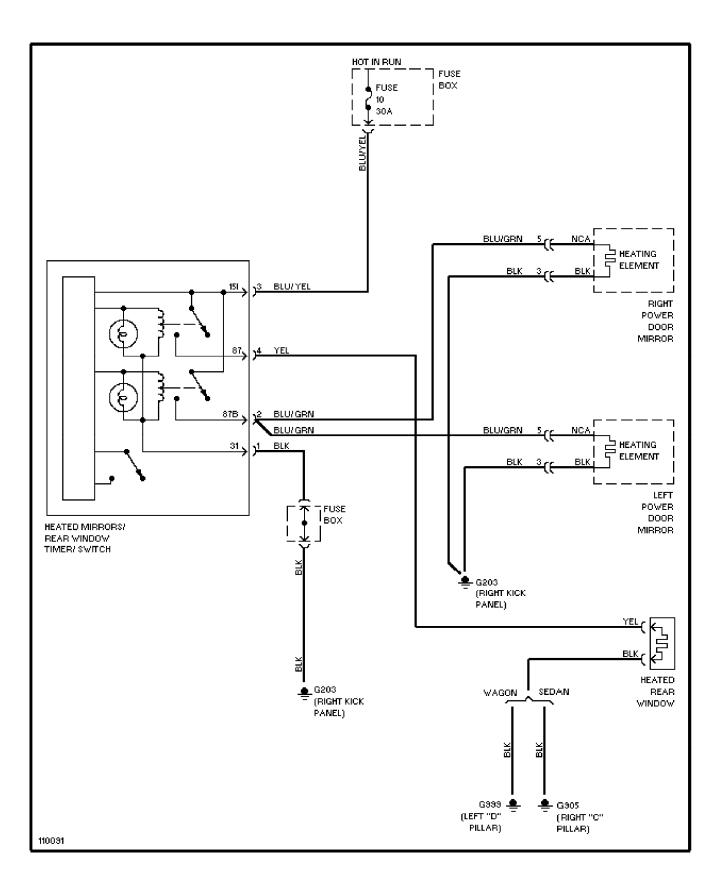
SYSTEM WIRING DIAGRAMS Defogger Circuit

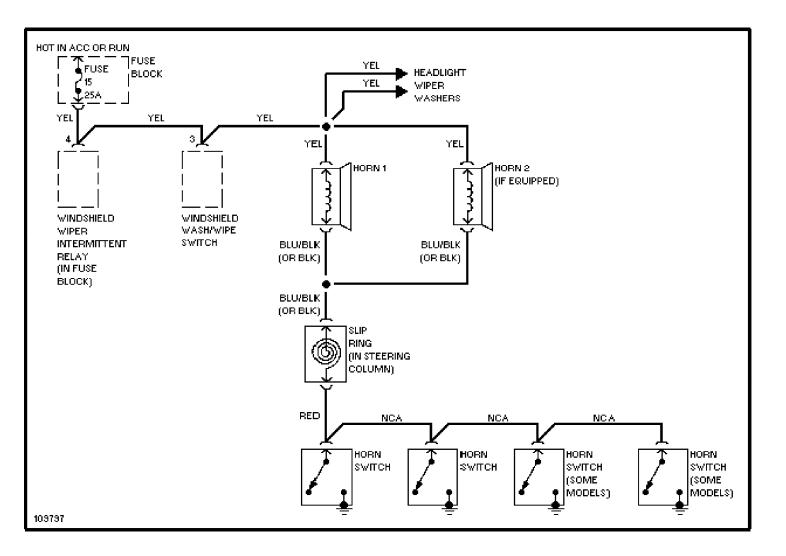
SYSTEM WIRING DIAGRAMS Horn Circuit

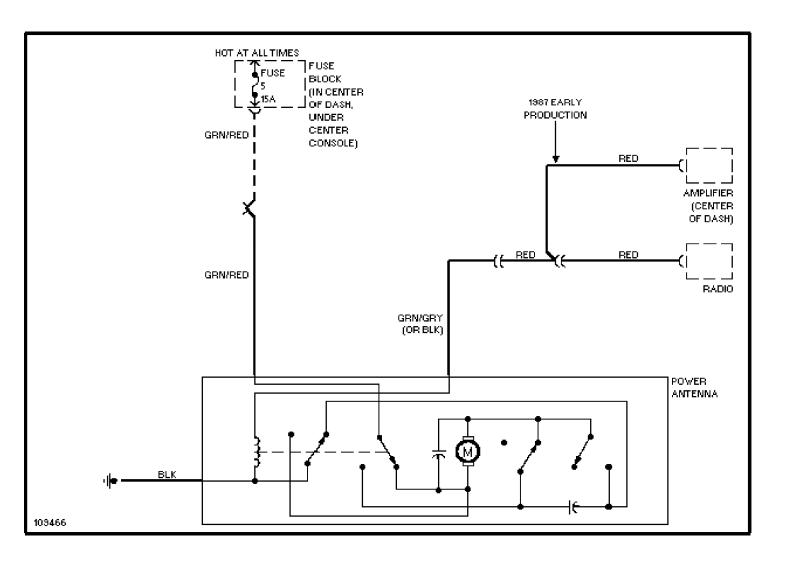
SYSTEM WIRING DIAGRAMS Power Antenna Circuit

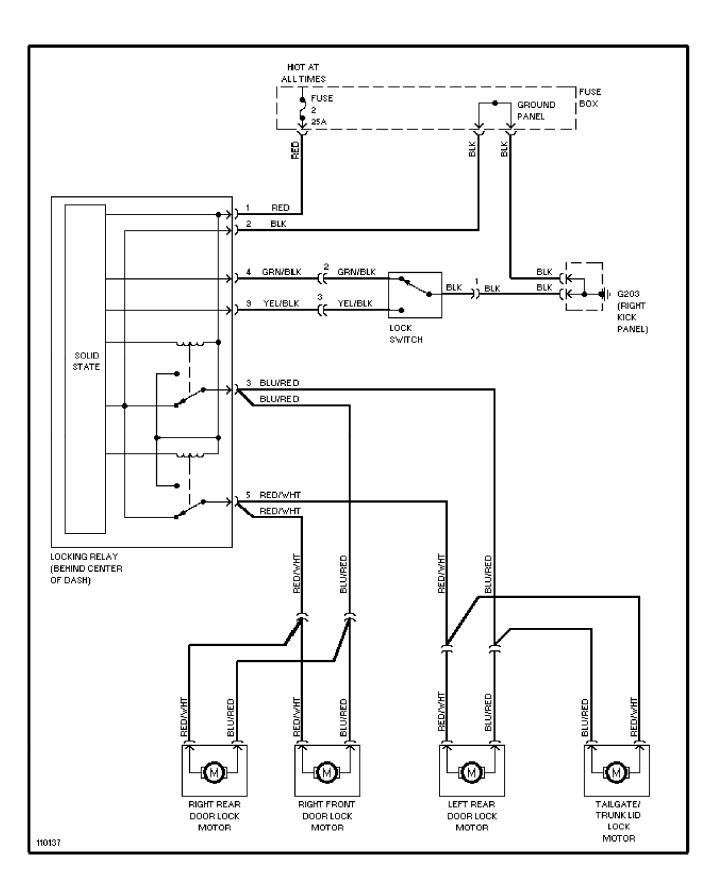
SYSTEM WIRING DIAGRAMS Power Door Lock Circuit

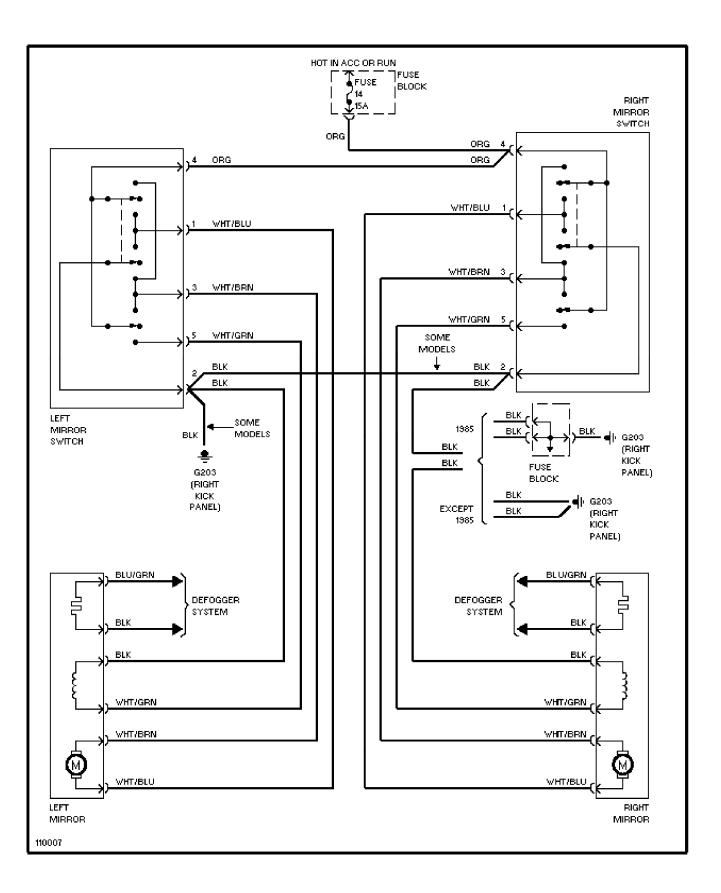
SYSTEM WIRING DIAGRAMS Power Mirror Circuit

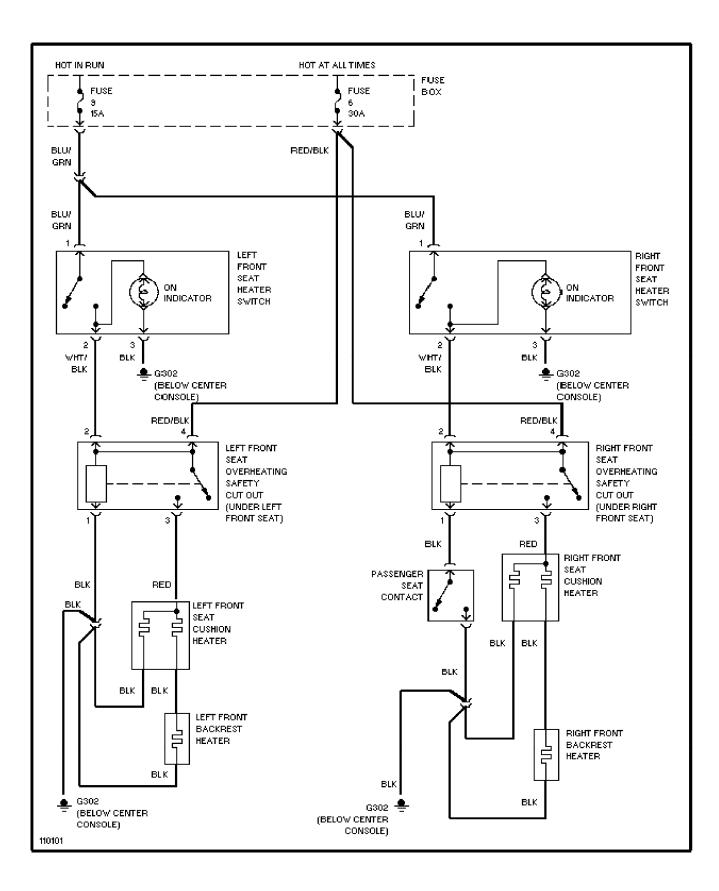
SYSTEM WIRING DIAGRAMS Heated Seats Circuit, Dual Output

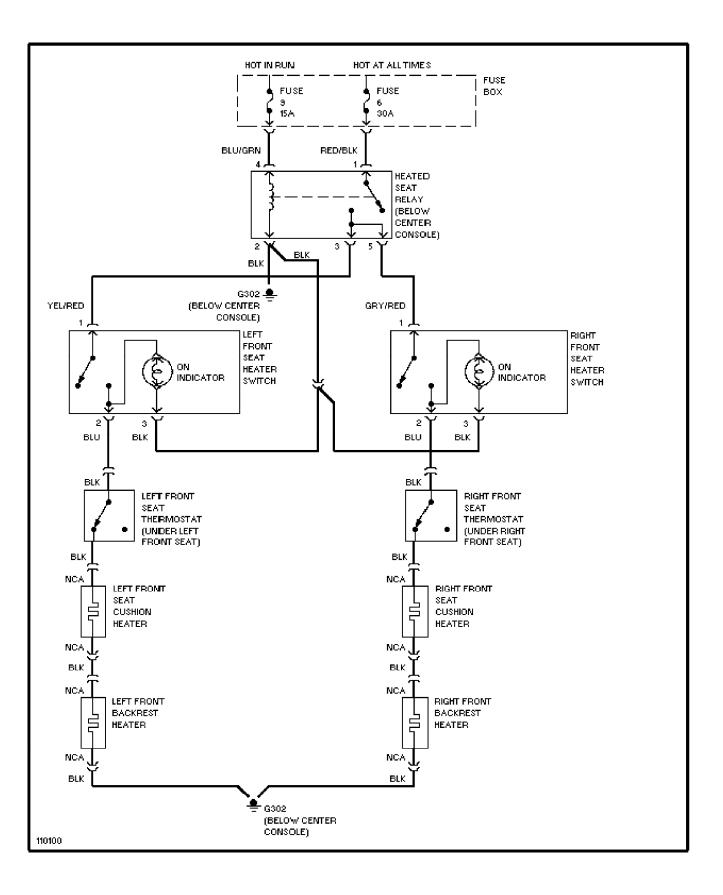
SYSTEM WIRING DIAGRAMS Heated Seats Circuit, Single Output

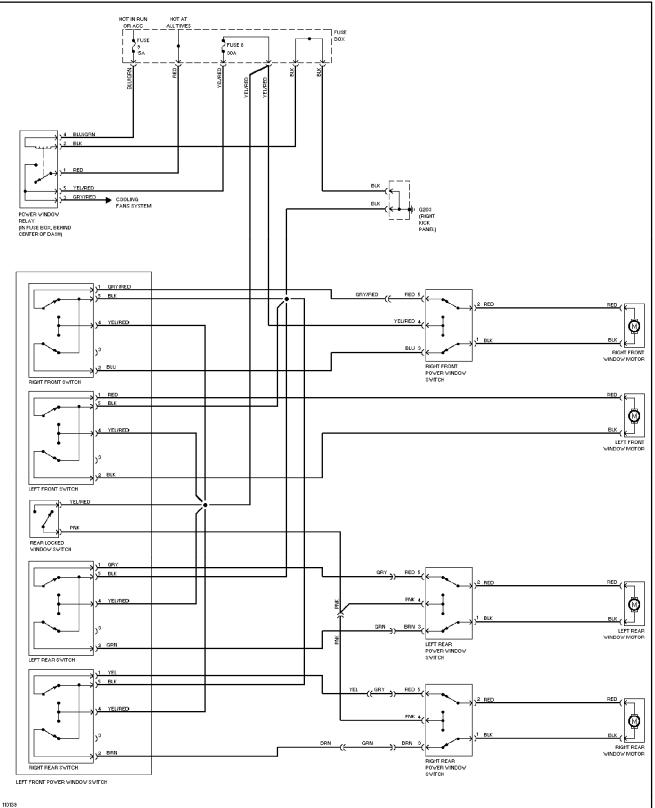
SYSTEM WIRING DIAGRAMS **Power Window Circuit**

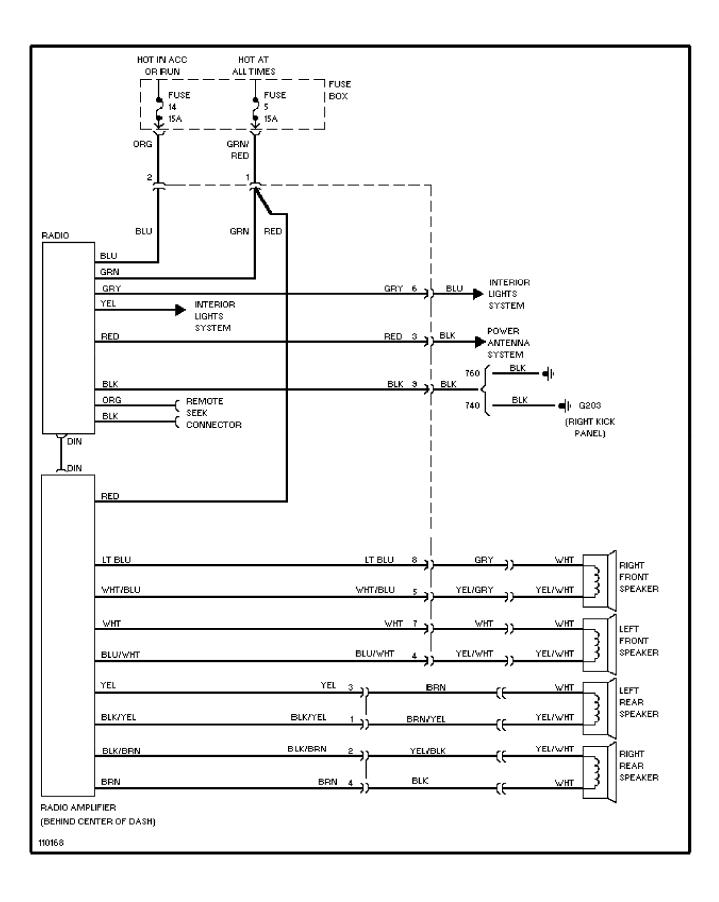
SYSTEM WIRING DIAGRAMS Radio Circuits

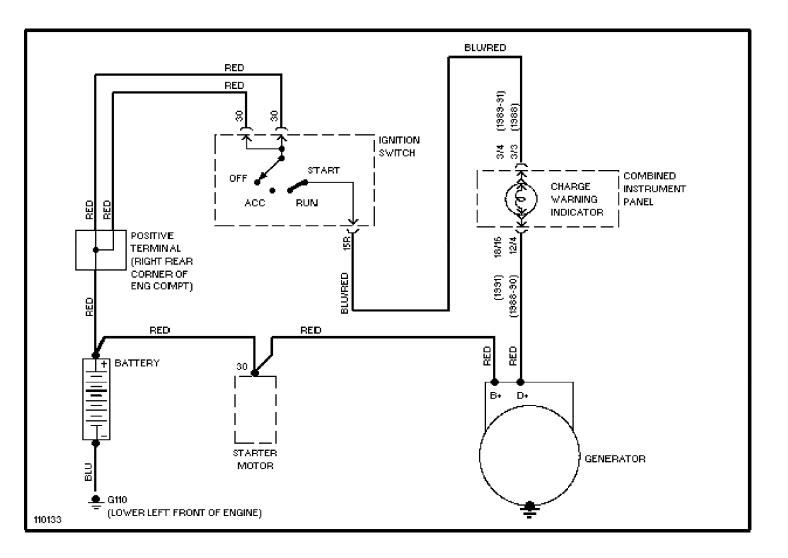
SYSTEM WIRING DIAGRAMS Charging Circuit

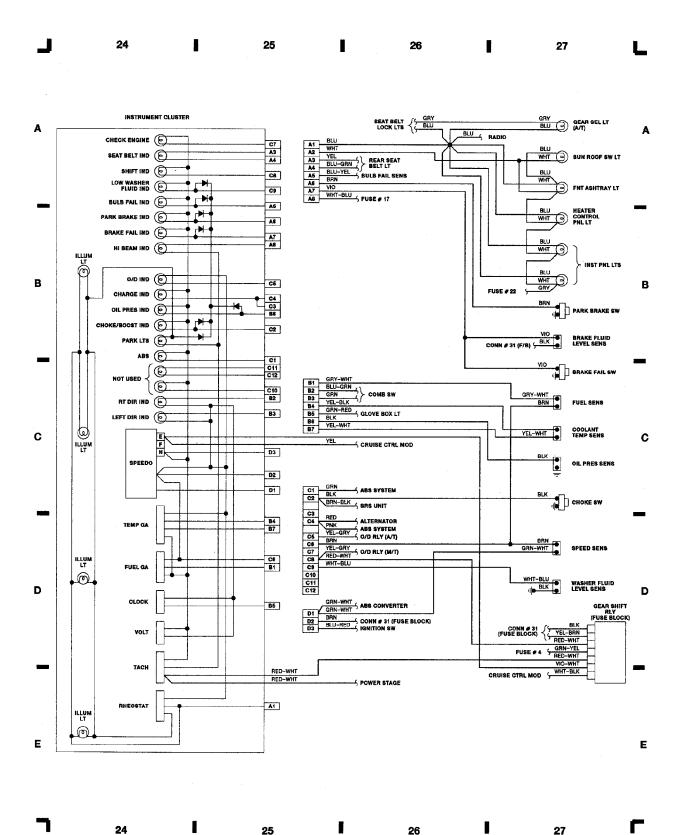
Fig. 7: Instrument Panel

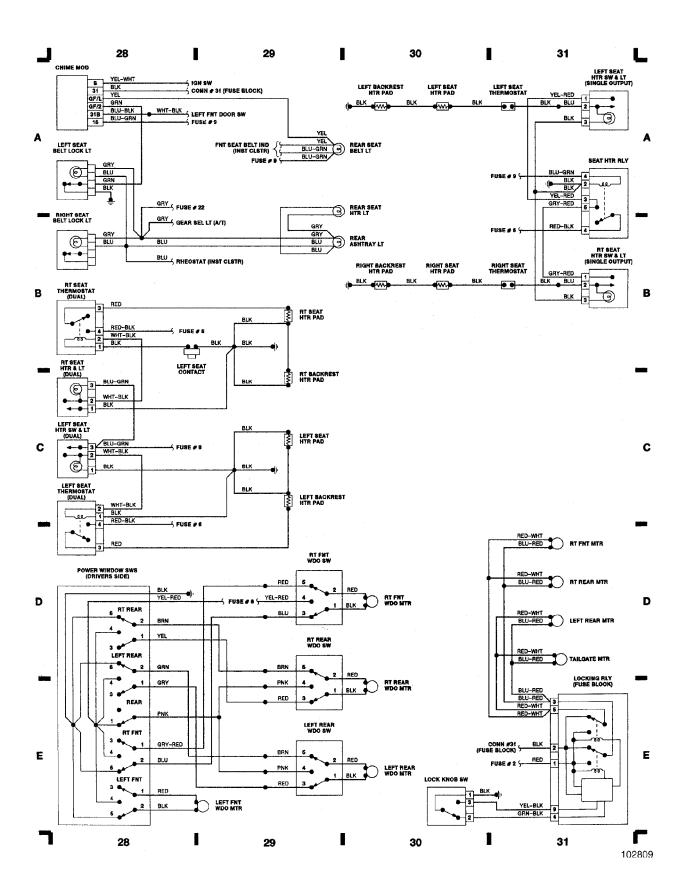
WIRING DIAGRAMS Fig. 8: Accessories (Cont.)

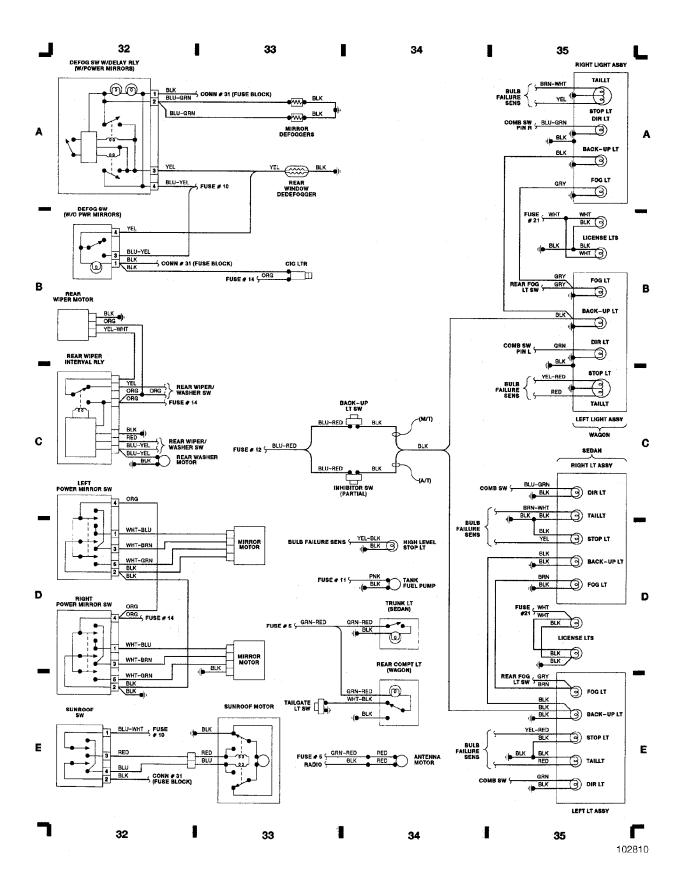
WIRING DIAGRAMS Fig. 9: Passenger Compartment & Taillights 1988 Volvo 740

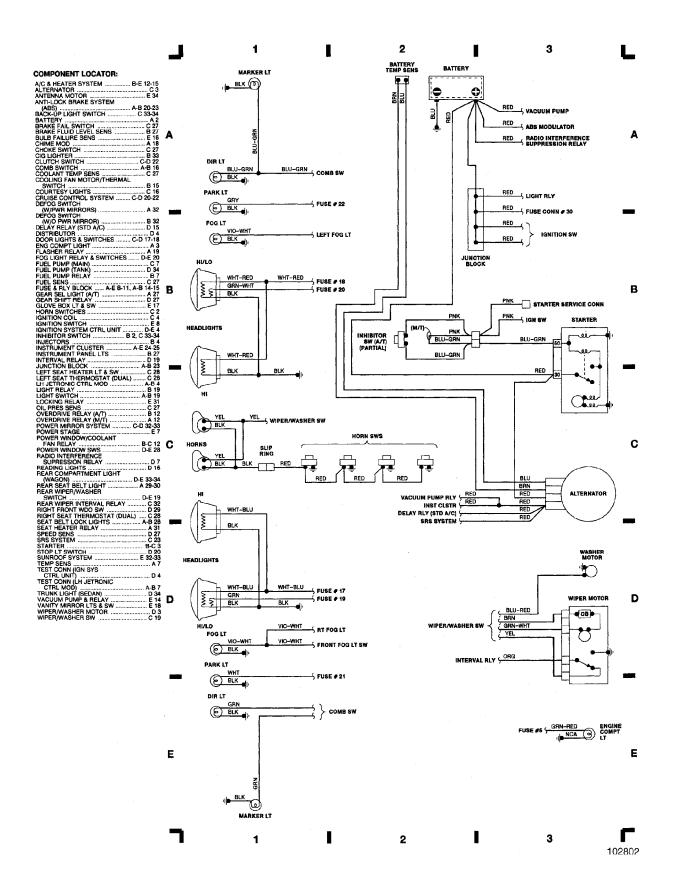
WIRING DIAGRAMS Fig. 1: Engine Compartment & Headlights 1988 Volvo 740

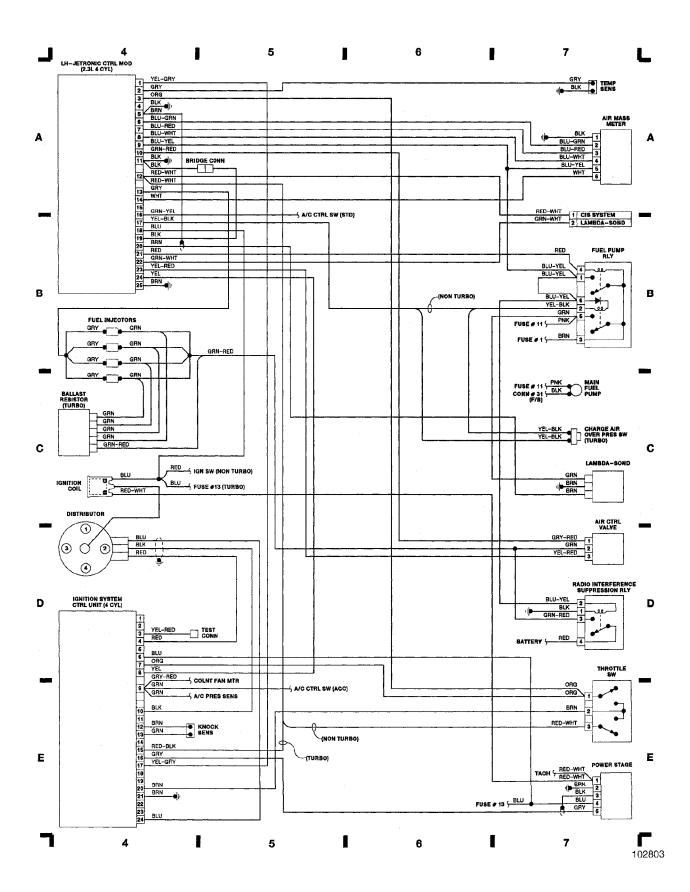
WIRING DIAGRAMS Fig. 2: Computer Engine Control

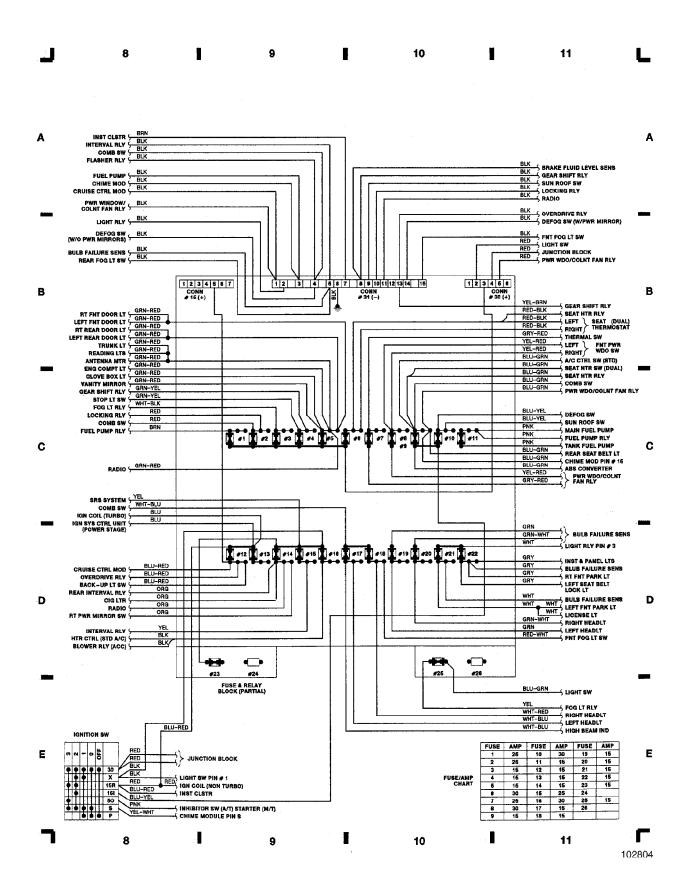
Fig. 3: Fuse Block

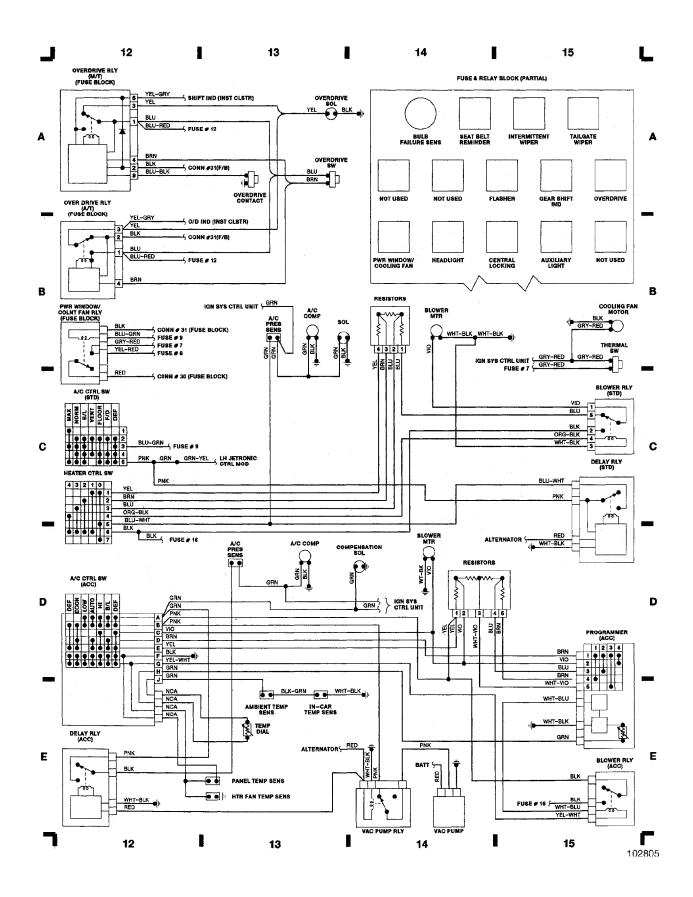
WIRING DIAGRAMS Fig. 4: Relays, Underdash & A/C & Heating 1988 Volvo 740

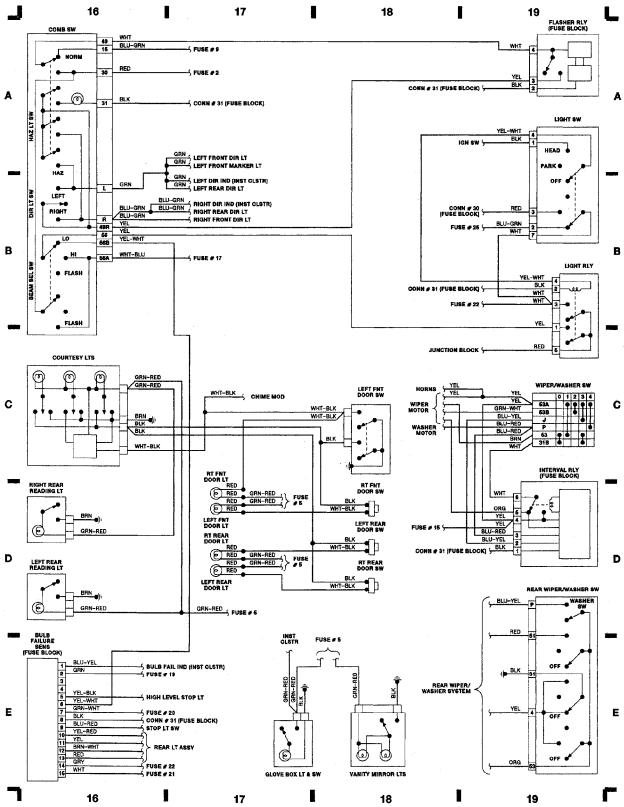
102806

WIRING DIAGRAMS Fig. 5: Steering Column Switches & Accessories 1988 Volvo 740 For x

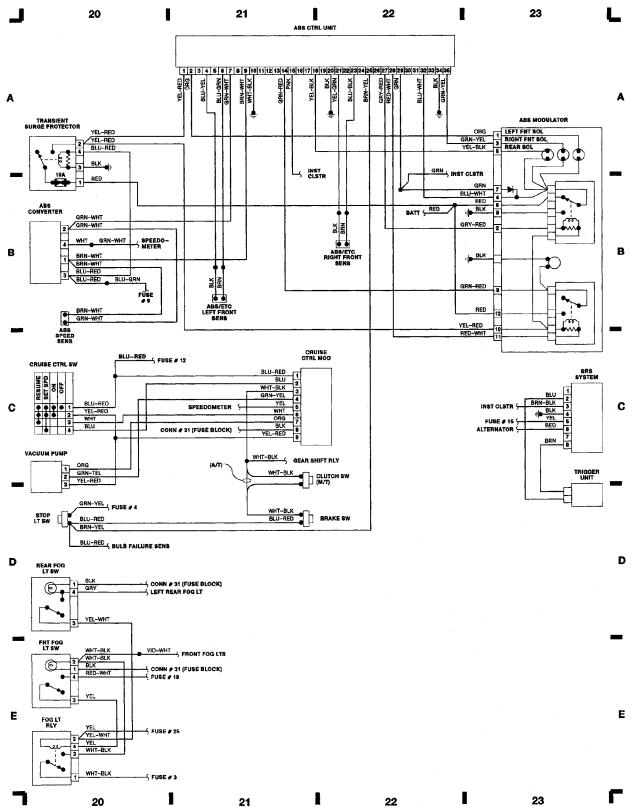
102807

WIRING DIAGRAMS Fig. 6: Anti-Lock Brake System, Cruise Control & Rear Defogger 1988 Volvo 740
